## **Arkwood Ground Water Path Forward Review**

**Updated: September 15, 2015**

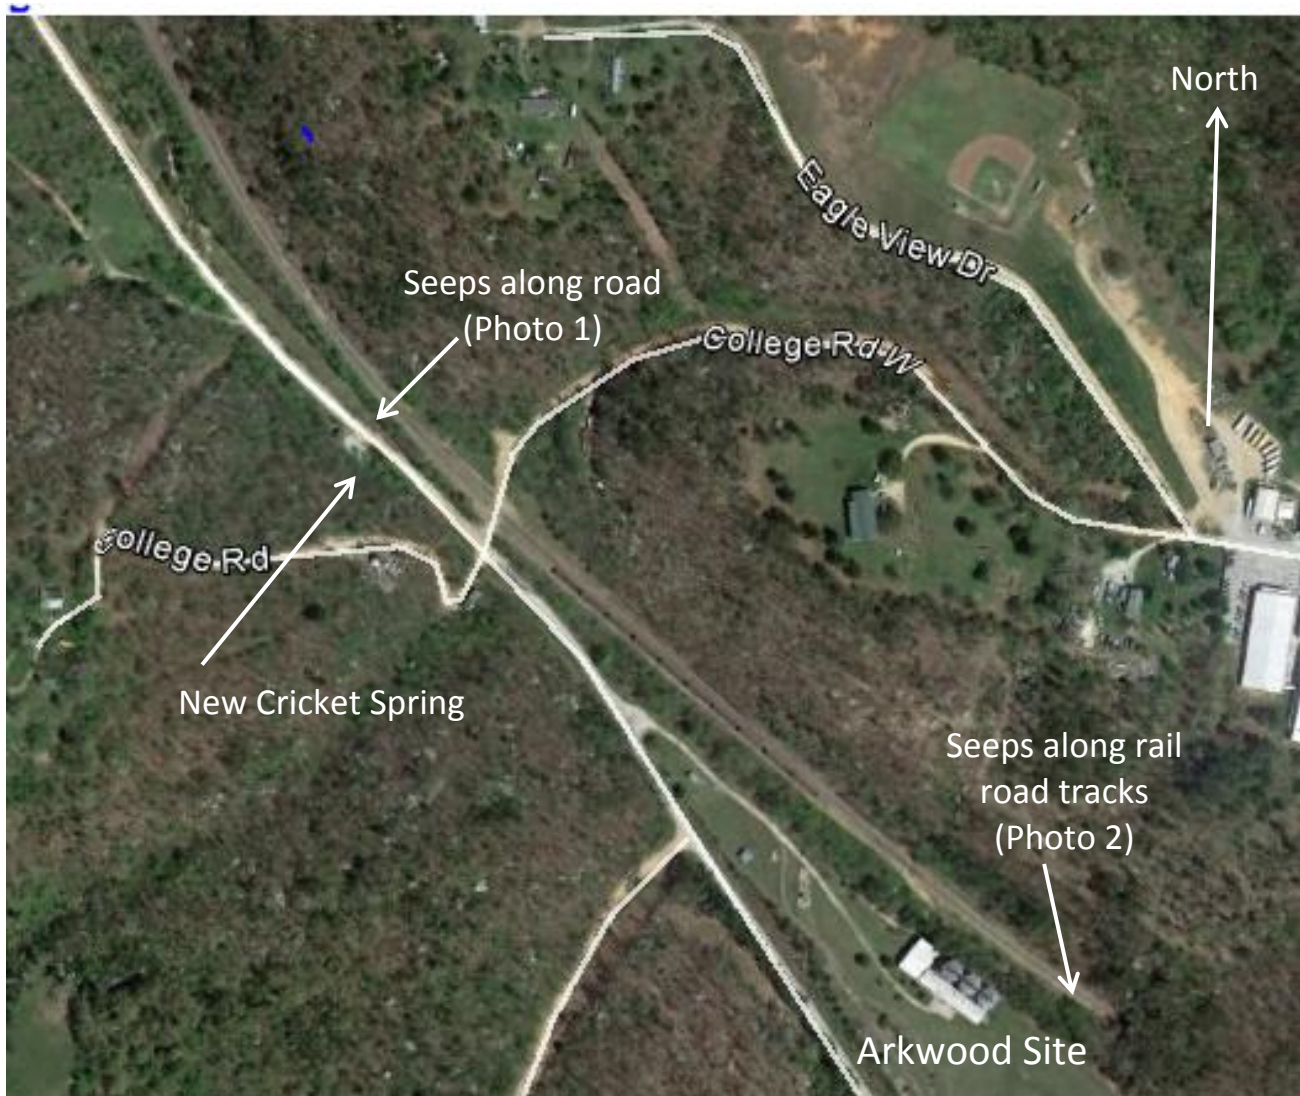
Photo No. 1. May 19, 2015. View to the southeast, up Old Cricket Road, between Cricket Spring and New Cricket Spring. Water seeping from ground on northeast side of road is flowing in the ditch at the edge of the road, over 48 hours after a 0.50-inch rainstorm. Discharge from New Cricket Spring treatment plant is on the opposite side of the road.

In addition, after the dye test and during a site visit in May 2015, seeps and discharges were observed by EPA and ADEQ on the northeast side of Old Cricket Road (across the road and downhill from New Cricket Spring), as shown in Photo No. 1 and near the Northwest portal of the railroad tunnel (just north of the site), in the area shown in Photo No. 2. These seeps are visual evidence of bypass flow and they indicate that not all water in the system discharges from New Cricket Spring.

Currently, a conceptual ground water model of complete capture of the solute plume at Arkwood by New Cricket Spring forms the basis for the ground water remedy. However, seeps and other discharges were observed in May 2015 by EPA and ADEQ and this observation indicates New Cricket Spring is being bypassed to an unknown extent. Thus, implementing an additional dye test at high flow and requiring additional monitoring wells will increase the ability to monitor karst flow and spring flow. This will provide information regarding the effectiveness of capture by New Cricket Spring and help establish whether an unacceptable amount of underflow or bypass flow is occurring with attendant contaminant transport, both solute (PCP) and colloidal (dioxin).
